GAS TURBINES BLADES—A CRITICAL REVIEW OF FAILURE ON FIRST AND SECOND STAGES

Rajni Dewangan^{1*}, Jaishri Patel¹, Jaishri Dubey¹, Prakash Kumar Sen¹
and Shailendra Kumar Bohidar¹

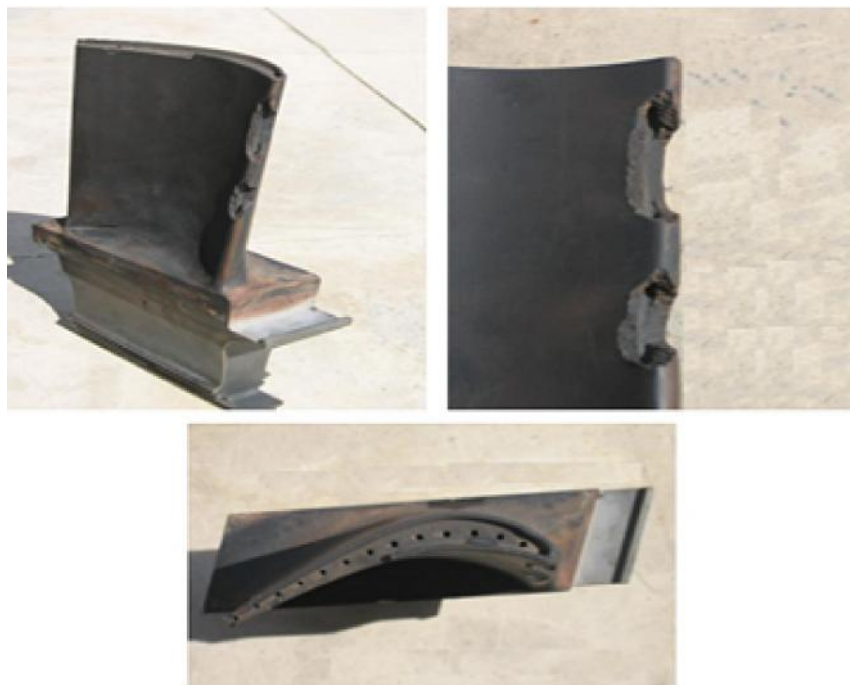
Figure 1: The General View of the First Stage Blade

Visual observation indicates that more than 90% of the first stage blades were damaged. Most of the damages are on the tip of the leading edge and also, bulk separation is obvious in this region. There are some signs of Foreign Objects Damage (FOD) on top of the leading edge and convex side (suction

side) of the airfoil. Figure 1 shows the general view of the first stage blade. Similar conditions were observed in other stages.

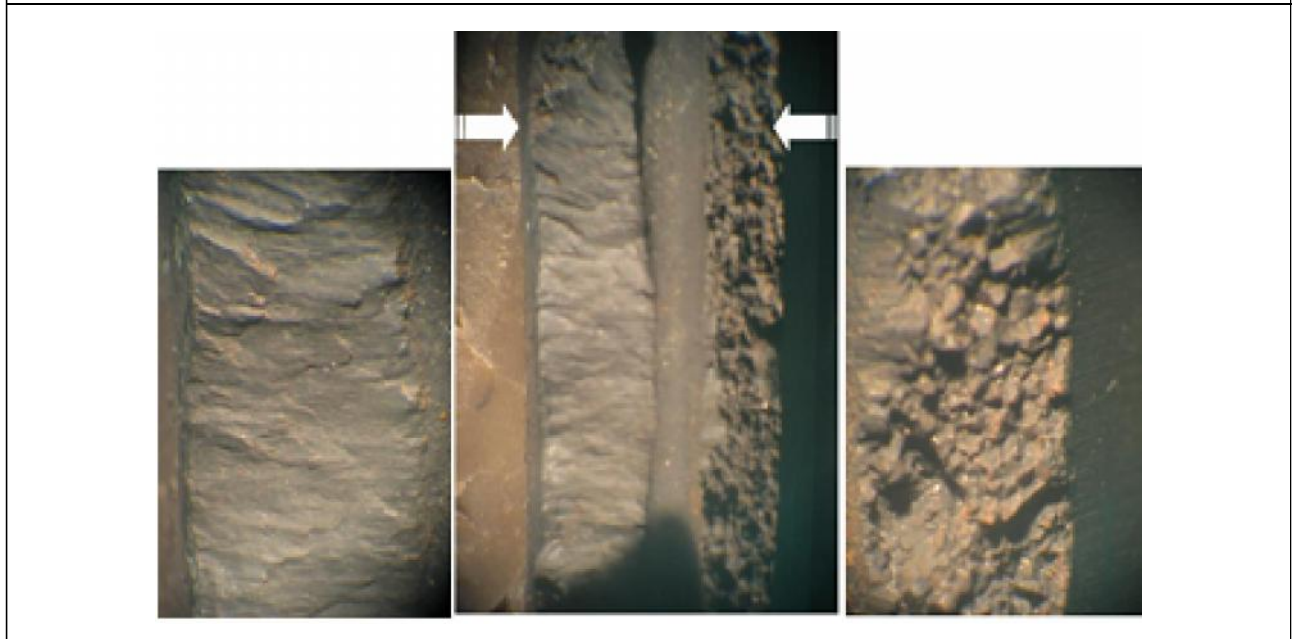
Figure 2: Stereo Microscopy of the Main Fracture Surface

Figure 2 shows the stereo micrographs of the fracture surface of a selected first stage blade. As can be seen, the fracture surface has two distinct types of flat and rough zones. There are some signs of erosion on the flat zone and brittle inter-granular fracture on the rough zone. Demonstrate the fracture surfaces in the concave (pressure) side and the cooling channel respectively. As seen in these figures, brittle inter-granular fracture is obvious near the pressure side and some surface cracks can be detected in the cooling channel surface because of exposure at high temperatures after being damaged, surface oxidation has occurred (Kazempour-Liacy *et al.*, 2011).

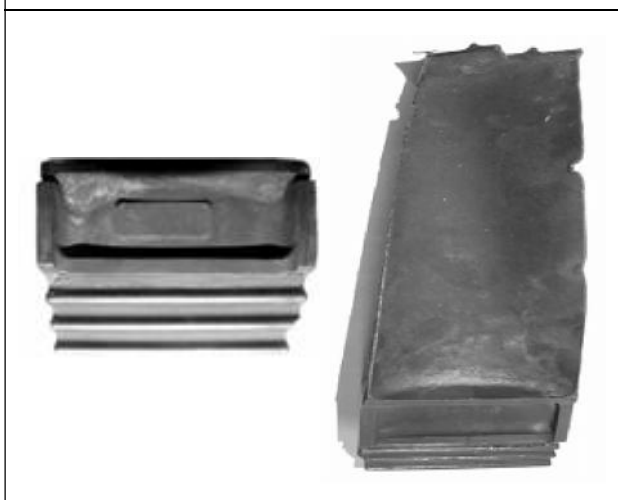
Figure 3: Blade Geometry and the Firtree Joint of a Damaged Turbine Blade

A damaged turbine blade which was retrieved from the accident site is shown in Figure. The firtree joint is also separately presented in the above mentioned figure. The remaining portion of the main fractured turbine blade under investigation which only includes the firtree root region, due to complete separation of the air

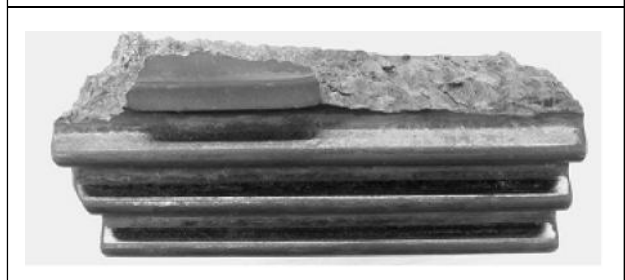
Figure 4: The Remaining Firtree Root Region of the Fractured Blade

foil section of the blade in the fracture process, is shown in Figure.

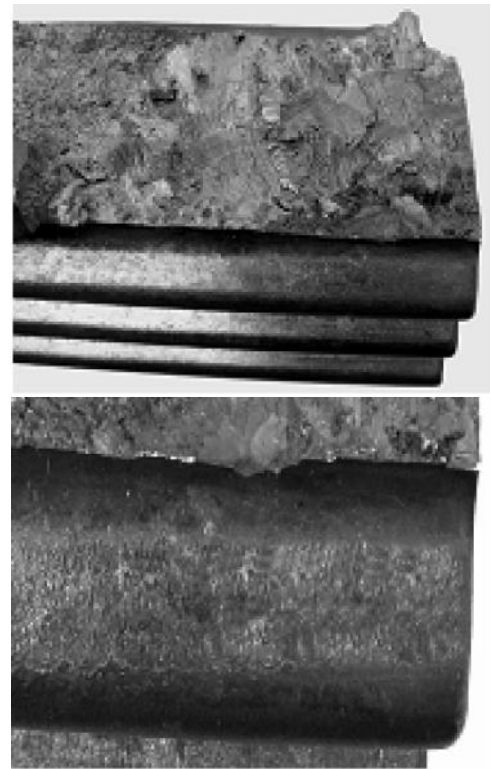
Figure 6: Magnified Views of Fatigue Fracture Region and a Wear Track

The general orientation of the fracture surface is nearly normal to the longitudinal axis of the blade. Visual examination of the fractured blade indicates that the fracture process involved minimal gross plastic deformation with no visible sign of any change in the cross section area at the fracture location. Thus the failure of the blade can be considered as a macroscopically brittle fracture process. Macroscopic appearance of the fracture surface is shown in Figure 6. Two distinct regions denoted as A and B, which is delineated by a curved superposed boundary

line, can be on the fracture surface. Region A has a more shiny appearance and extends from the boundary to the trailing edge side of

the blade and covers about 40% of the fracture surface. Region B located in the opposite side extends up to the leading edge side of the blade. The fracture mechanisms in these regions are analyzed by SEM fractography.

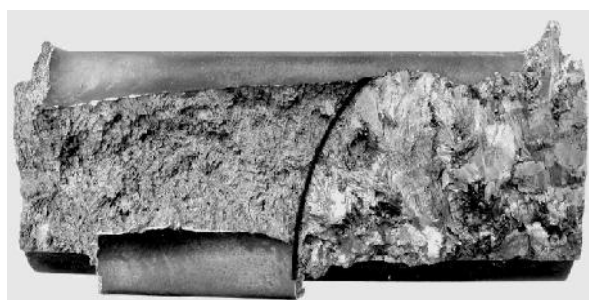
Figure 5: Fracture Surface of the Blade

The side view of the fractured blade presented in Figure 5 shows that the failure surface is located at the top firtree root.
