# Failure Analysis of S55C Medium Carbon Steel for the Pickup Crankshaft

**Abstract**—There have been reports from service centers of important problems of a diesel engine crankshaft in mini trucks. All crankshafts crack from the same region, the fracture occurred in the first crankpin of the crankshaft. The crankshaft is made from JIS-S55C hardened medium carbon steel. A series of experiments including chemical analysis, macro and microstructural analysis, mechanical properties test, and numerical stress analysis. The results of fracture surface of this crankshaft were caused by fatigue with the detection of beach marks, ratchet marks, river marks, cleavage fracture and fatigue striations which these results indicate that the fracture mode of brittle fracture. The microstructure is composed of perlite-ferrite on the outer surface showed some coating nitriding layers, most hard coating is not found, the hardness test revealed an uneven hardness distribution, the maximum hardness on the center of the shaft measuring 309 HV, which is more than compared to the outer surface is 259 HV for these applications. It was found that the hardness value was abnormal. This is consistent with th

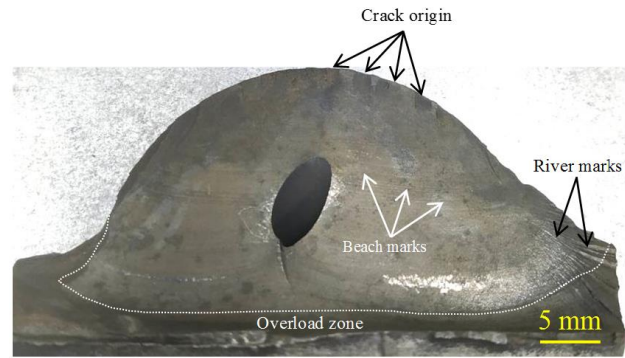
An analysis of the fracture surfaces of the crankshaft at low magnification by zoom stereo microscope is shown in Fig. 4 revealing where multiple crack origins actually started. The crack then expands slowly through the fatigue zone, an area that has been failed by cyclic loading. During this slow crack propagation, there is a change in load which corresponds to the crack growth rate that appears on beach marks.

Fig. 4. Fracture characteristics of the crankshaft caused by fatigue.

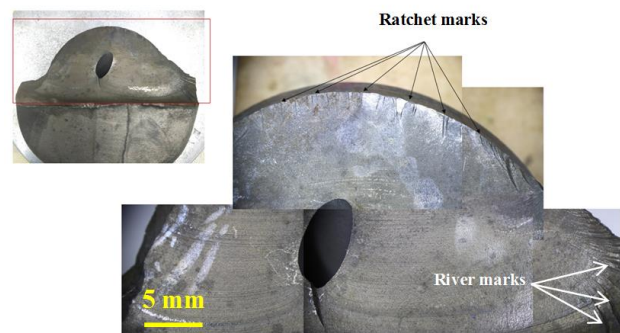
In addition, there are two other important features that appear on the fracture surface from fatigue of the crankshaft. The first of these is the ratchet mark in Fig. 5 shows the boundary or line between two crack origins, and the ratchet mark is between them. The fracture images of the failed crankshaft, it was found that the fracture had multiple origins and because of the workpiece subjected to high total stress or the area is a stress concentration point. The second important feature is the shape of the fracture as a river mark as shown in Fig. 5, because the appearance on the fracture surface is like that of tributary rivers. The pattern predominantly shows the rapid expansion of the fatigue zone and shows the direction of crack propagation.

Fig. 5. Fracture images of the crankshaft shows ratchet marks and river marks at 1x.

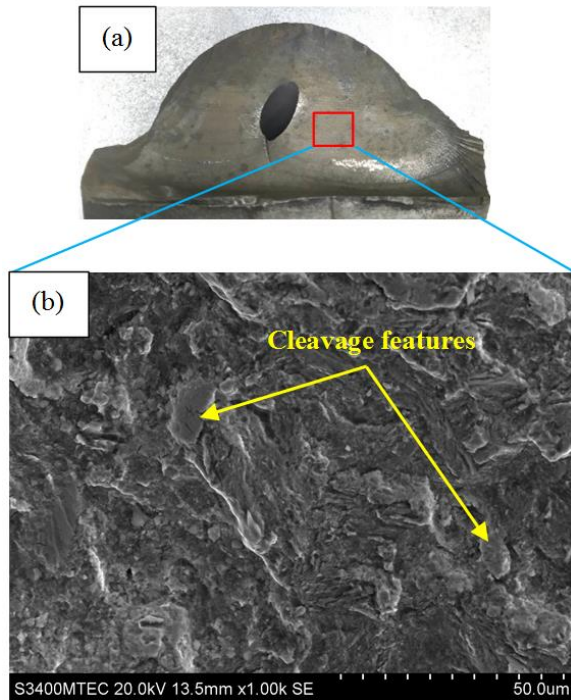
Examine the fracture surface of the failed crankshaft by scanning electron microscopy. A photograph of the central region fracture is shown beach marks in Fig. 6(a). Fig. 6(b) High magnification images in the same area reveal a cleavage fracture near the central region of the fracture [12]. A photograph at the surface region using a scanning electron microscope shows the crankshaft fracture area in Fig. 7(a). Expansion of beach marks on most fractured surfaces are wavy lines that leave a mark on the beach, while Fig. 7(b) shows an enlarged section showing fatigue striations showing the direction of displacement between atoms, with fatigue striations in each stress period or each stress cycle acting on the specimen. These lines can only be seen by examination using a high-powered microscope [12]. Therefore, cleavage fracture is the fracture failure form of the crankshaft, and fatigue striations is the fatigue fracture feature.

Fig. 6. SEM micrograph showing (a) Beach marks at 1x. (b) High magnification with cleavage fracture at 1.00kx, 50  $\mu$ m.

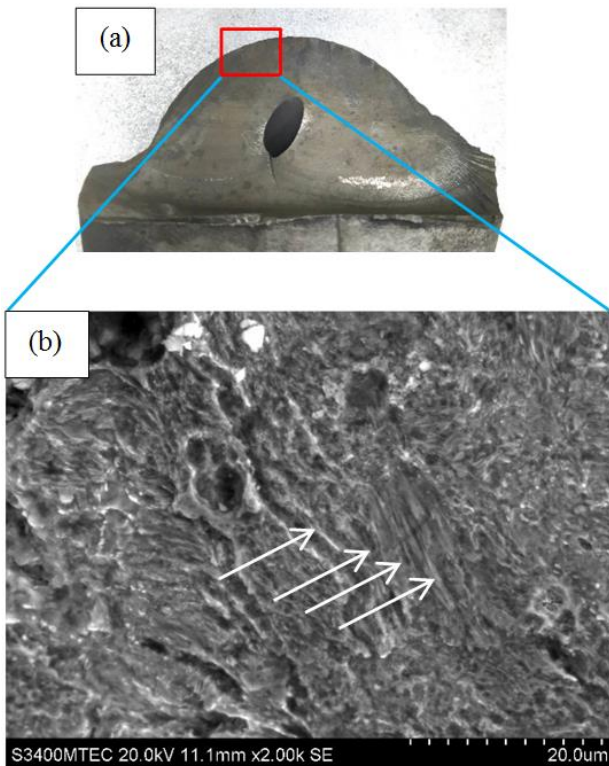
Fig. 7. SEM micrograph showing (a) SEM micrograph showing 1x. (b) Magnification of the visible fracture area showing fatigue striations and the direction of motion between dislocations of atoms at 2.00kx, 20  $\mu$ m.

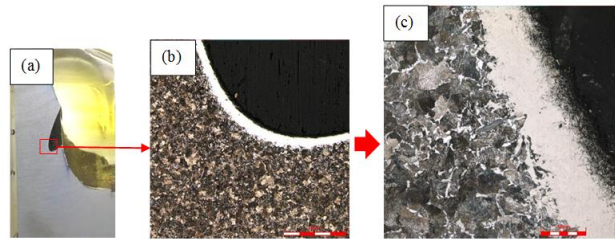
Metallographic examinations as shown in Fig. 8(b) presents the same image at magnification  $200 \times 40 \mu$ m. In Fig. 8(c) the surface of the crankshaft shows that the microstructure is composed of perlite-ferrite with a hard coating layer or nitriding layer about 500  $\mu$ m in size.

Fig. 8. Optical photomicrograph of the failed crankshaft. (a) Low magnification image of the failed crankshaft approximation 1x. (b) The same image at magnification  $200 \times 40 \mu$ m. (c) Magnification of the surface is composed of perlite-ferrite with a hard coating layer or nitriding layer about 500 micrometers in size with a magnification of  $1000 \times 50 \mu$ m.

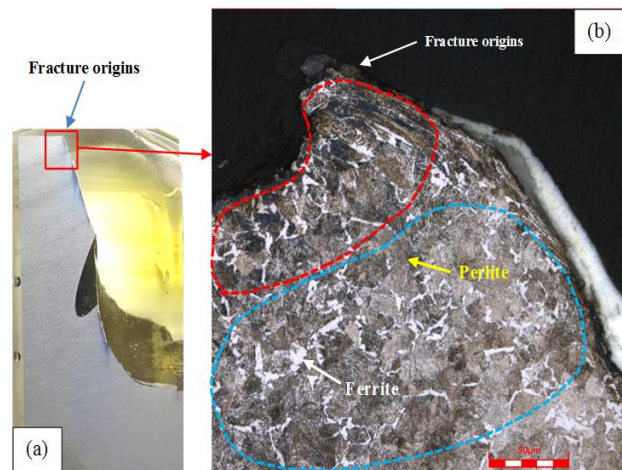
Fig. 9 Optical micrographs of failed crankshaft show (a) Low magnification image (1x) at the outer surface of the shaft. (b) shows the microstructures are perlite-ferrite grain boundary on the fracture initiation region at magnification  $500 \times 50 \mu$ m.

The fracture initiation region at the outer surface of the failed crankshaft is shown in Fig. 9(a), the fracture origins in an example. Fig. 9(b) is the same image at

magnification  $500 \times 50 \mu\text{m}$  at the fracture origin in the red line color, found that the ferrite (white) has a fine grain boundary, and in the blue line color on the fracture expansion zone, it was found that the ferrites had coarse grain boundary than those at the fracture initiation region. Therefore, the size of the grain boundaries of ferrite resulting in decrease mechanical properties and the strength of the material, also have the effect on the fatigue strength of these specific areas [11]. Fig. 10(a) shows low magnification image (1x) with two telescopes at the surface and core of the shaft. Fig. 10(b) The cross-section and microstructure of the outer surface showed some coating layers, most hard coating is not found. Fig. 10(c) The central axis of the crankshaft contains a perlite-ferrite microstructure and manganese sulfite inserted in the ground metal.

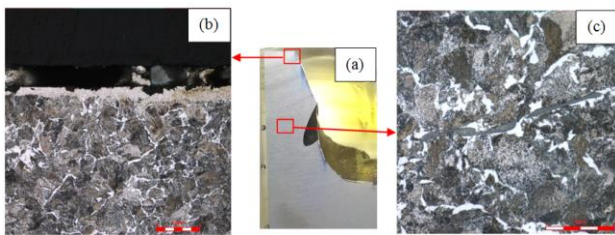
Fig. 10. Optical photomicrograph of the failed crankshaft. (a) Low magnification image of failed crankshaft approximation 1x. (b) Magnification of the outer surface composed of perlite-ferrite showed some coating layers, most hard coating is not found, magnification  $500 \times 50 \mu\text{m}$ . (c) Magnification of the central axis is composed of perlite-ferrite and found manganese sulfite inserted in the ground metal, magnification of  $1000 \times 40 \mu\text{m}$ .

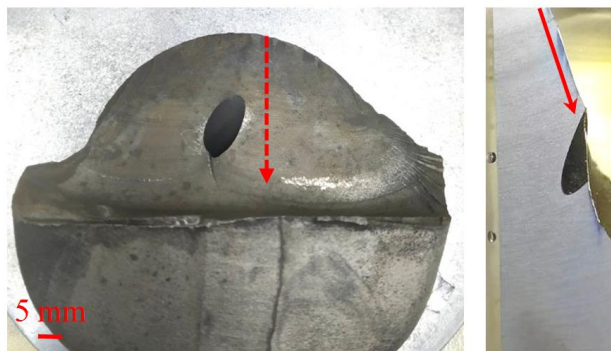
In addition, the microhardness measurement of the cross-section is initiated by pressing from the outer surface of the crankshaft through the center axis in all 25 points of the crankshaft as shown in Fig. 11. The results of the hardness test are shown in Fig. 12, the maximum hardness on the center of the shaft measuring 309 HV, which is more than compared to the outer surface is 259 HV for these applications. It was found that the hardness value was abnormal. This is consistent with the experimental results of the surface microstructure which showed some coating layers, while the hard coating is not found.

Fig. 11. The failed crankshaft hardness measurement line is measured from the case to the core of the shaft at 1x.

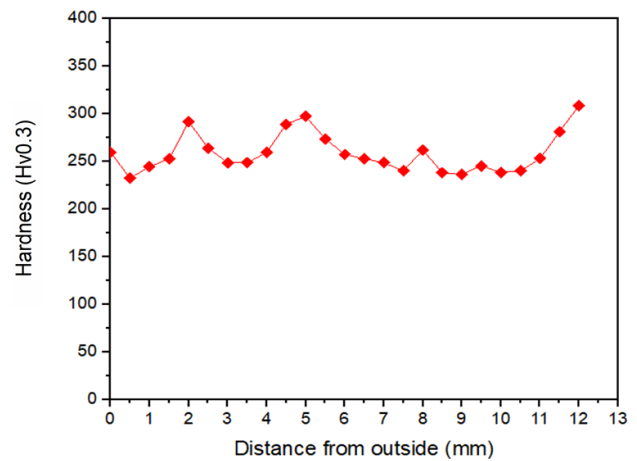
Fig. 12. The graph shows the hardness layer of the failed crankshaft.

3. The hardness test revealed an uneven hardness distribution, the maximum hardness on the center of the shaft measuring 309 HV, which is more than compared to the outer surface is 259 HV for these applications. It was found that the hardness value was abnormal. This is consistent with the experimental results of the surface microstructure which showed some coating layers, while the hard coating is not found.

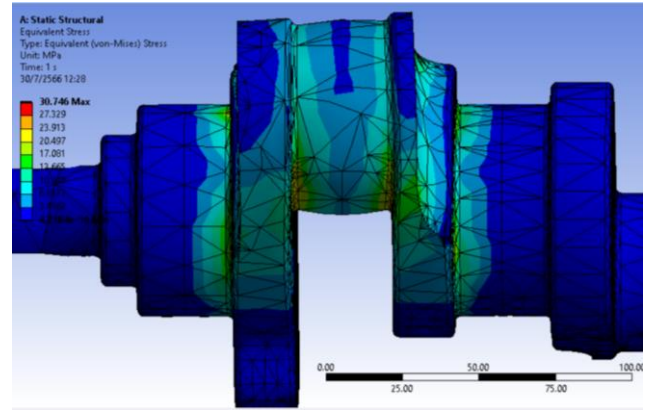
applied in the stress analysis on the crankshaft. The maximum equivalent von Mises stress in Fig. 17 at the crankpin-web zone of the crankshaft is 30.746 MPa, which is 6% of the yield strength of the crankshaft standard material S55C steel [15]. Consider Fig. 18 showing a minimum safety factor min is 2.80. It is evident in these cases that the result given by the calculation method and the finite element analysis are very similar.

Fig. 17. The von Mises stress distribution in the web fillet of crankpin and fracture region.

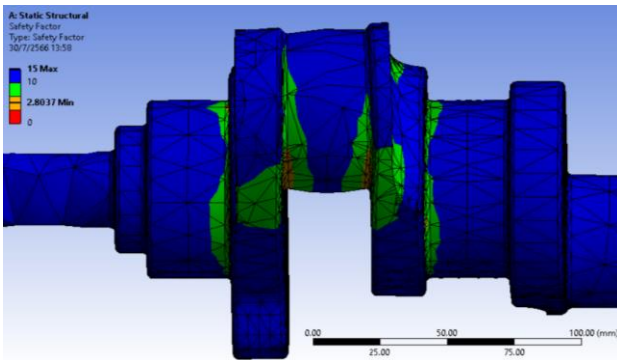
$$n_f = \frac{S_e}{\sigma_{\max}} = \frac{77.70}{30.746} = 2.52$$

Fig. 18. The safety factor obtained from the numerical simulation.

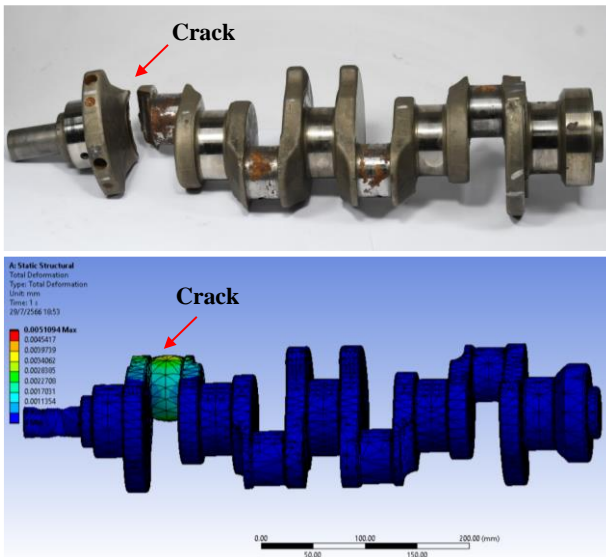
Based on the results of numerical simulation using the ANSYS Workbench program as shown in Fig. 19, the maximum equivalent von Mises stresses in the crankshaft can be observed to deliver a maximum deformation at the junction between the first crankpin and the web, similar to the appearance of crankshaft cracks caused by fatigue after use for 125,000 km. In conclusion, the cause of the crankshaft damage is the fatigue of the shaft material.

Fig. 19. Comparison of crack appearance between actual usage and stress obtained by simulation using ANSYS Workbench program.
