# Failure Analysis of Hydraulic Rotary Drill Rods in a Limestone Mine

Abstract—Failure analysis of two hydraulic rotary drills used for rock drilling was carried out. Chemical analysis, metallurgical examination, surface fractography and hardness measurement were used for the analysis. The failed drill rods composition matched with low alloy 31NiCrMo13-4 grade steel. The hardness measurement results suggested that the drilled rods were surface hardened. Surface fractography examination revealed that crack initiation of the fractured drill rods started at the outer surface, especially at the joint between the drill rod and drill bit. The mode of failure was found to be fatigue. The stress concentration locating at groove of threads at the joint was likely to cause the crack initiation. Propagation of fracture was observed with the evidence of beach mark, resulting from continuous nominal low stress.

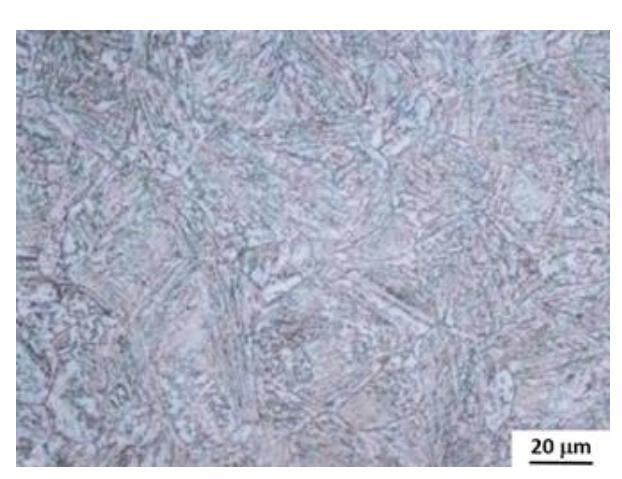
The microstructure of the sample near the surface was examined by the optical microscope as shown in Fig. 3. It can be seen that the microstructure was bainite structure, consisting of alpha ferrite matrix (white) embedded with cementite (black). This was the result of carburizing surface hardening. The presence of hard cementite phase could lead to a brittle fracture. Compared to [6], the martensite structure was not observed after the surface hardening in the sample due to the low hardenability, low carbon content or unsuccessful surface hardening. As tempered martensite structure could also be observed in the low carbon content (0.2wt%C) steel alloy (18CrNiMo7-6 grade) [4].

Figure 3. Optical micrograph showing bainite microstructure near the surface

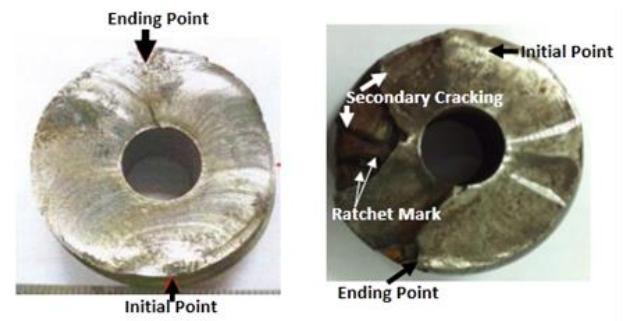
The surface fractography examination of the failed drill rods was performed using stereomicroscope. In Fig. 4, it was clear that the initial point of the fracture was found at the outer surface at threads coupled with the drill bits. This normally acted as stress raiser, leading to stress concentration and crack initiation. The second cracking was also observed in the second drill rod (right), as the ratchet marks appeared similar to [6]. Additionally, the presence of the beach and ratchet marks indicated high local stress [7]. Based on information of the drills used in the operation, the second drill rods were intensively operated within a shorter period of time (32 days) and relatively higher rate of drilling, comparing to the first drill rod. Due to the high drilling rate, this might introduce the secondary crack in the second drill rod.

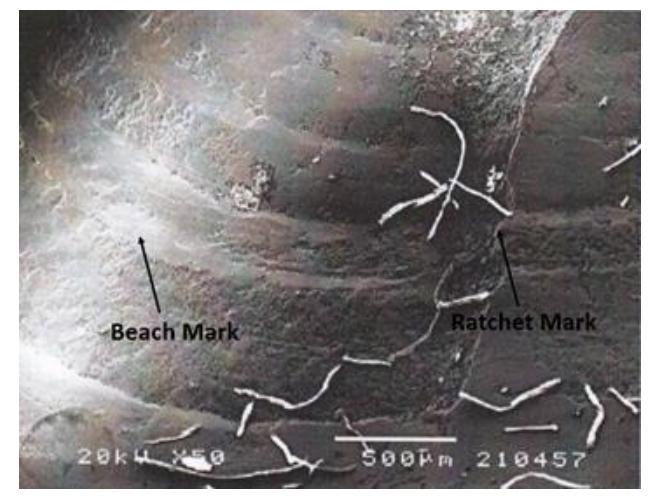
Fig. 5 shows the beach and ratchet marks appearing on the surface fracture. This is the evidence indicating that the failure was attributed to fatigue. It can be said that the fracture was in brittle mode as no plastic deformation was clearly observed on the fracture surface and no overload zone was observed.

Figure 5. SEM Micrograph showing beach mark and rachet mark on the fracture surface
