# Failure Analysis of S55C Medium Carbon Steel for the Pickup Crankshaft

Abstract—There have been reports from service centers of important problems of a diesel engine crankshaft in mini trucks. All crankshafts crack from the same region, the fracture occurred in the first crankpin of the crankshaft. The crankshaft is made from JIS-S55C hardened medium carbon steel. A series of experiments including chemical analysis, macro and microstructural analysis, mechanical properties test, and numerical stress analysis. The results of fracture surface of this crankshaft were cause by fatigue with the detection of beach marks, ratchet marks, river marks, cleavage fracture and fatigue striations which these results indicate that the fracture mode of brittle fracture. The microstructure is composed of perlite-ferrite on the outer surface showed some coating nitriding layers, most hard coating is not found, the hardness test revealed an uneven hardness distribution, the maximum hardness on the center of the shaft measuring 309 HV, which is more than compared to the outer surface is 259 HV for these applications. It was found that the hardness value was abnormal. This is consistent with the exp

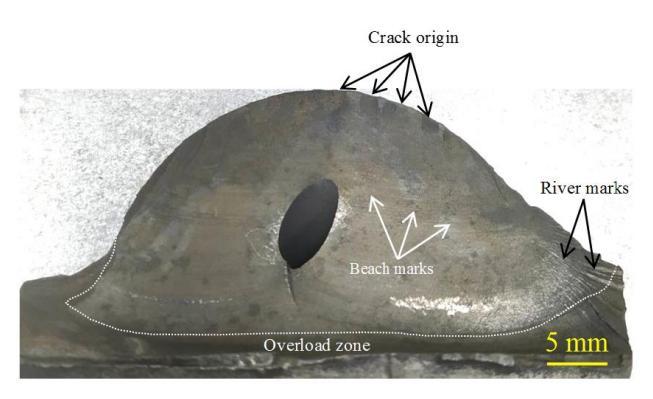
An analysis of the fracture surfaces of the crankshaft at low magnification by zoom stereo microscope is shown in Fig. 4 revealing where multiple crack origins actually started. The crack then expands slowly through the fatigue zone, an area that has been failed by cyclic loading. During this slow crack propagation, there is a change in load which corresponds to the crack growth rate that appears on beach marks.

Fig. 4. Fracture characteristics of the crankshaft caused by fatigue.

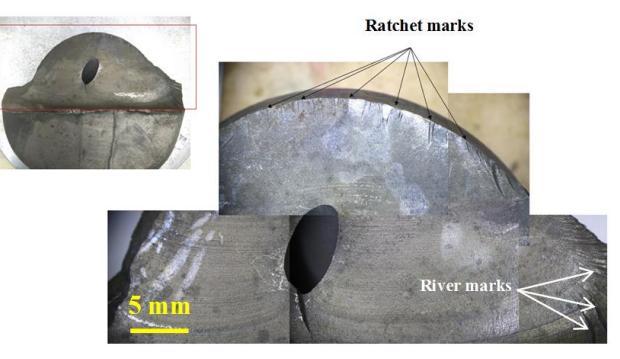
In addition, there are two other important features that appear on the fracture surface from fatigue of the crankshaft. The first of these is the ratchet mark in Fig. 5 shows the boundary or line between two crack origins, and the ratchet mark is between them. The fracture images of the failed crankshaft, it was found that the fracture had multiple origins and because of the workpiece subjected to high total stress or the area is a stress concentration point. The second important feature is the shape of the fracture as a river mark as shown in Fig. 5, because the appearance on the fracture surface is like that of tributary rivers. The pattern predominantly shows the rapid expansion of the fatigue zone and shows the direction of crack propagation.

Fig. 5. Fracture images of the crankshaft shows ratchet marks and river marks at 1x.

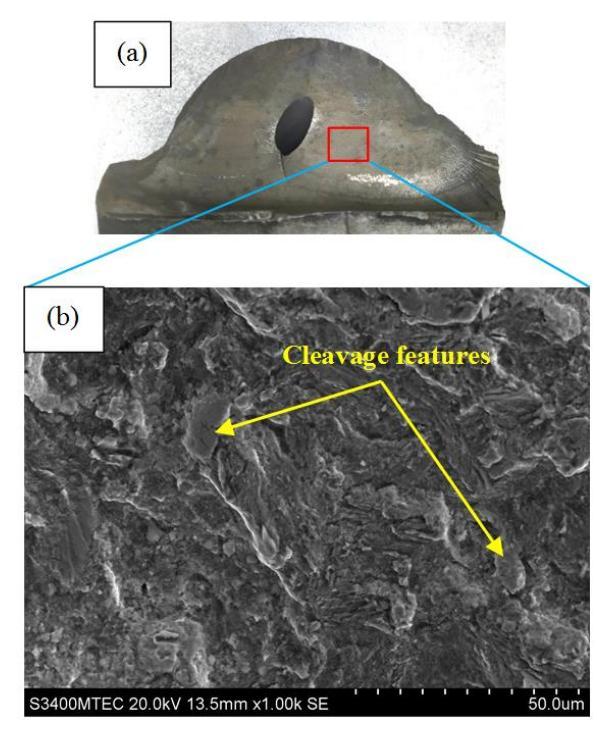
Examine the fracture surface of the failed crankshaft by scanning electron microscopy. A photograph of the central region fracture is shown beach marks in Fig. 6(a). Fig. 6(b) High magnification images in the same area reveal a cleavage fracture near the central region of the fracture [12]. A photograph at the surface region using a scanning electron microscope shows the crankshaft fracture area in Fig. 7(a). Expansion of beach marks on most fractured surfaces are wavy lines that leave a mark on the beach, while Fig. 7(b) shows an enlarged section showing fatigue striations showing the direction of displacement between atoms, with fatigue striations in each stress period or each stress cycle acting on the specimen. These lines can only be seen by examination using a high-powered microscope [12]. Therefore, cleavage fracture is the fracture failure form of the crankshaft, and fatigue striations is the fatigue fracture feature.

Fig. 6. SEM micrograph showing (a) Beach marks at 1x. (b) High magnification with cleavage fracture at 1.00kx, 50 μm.

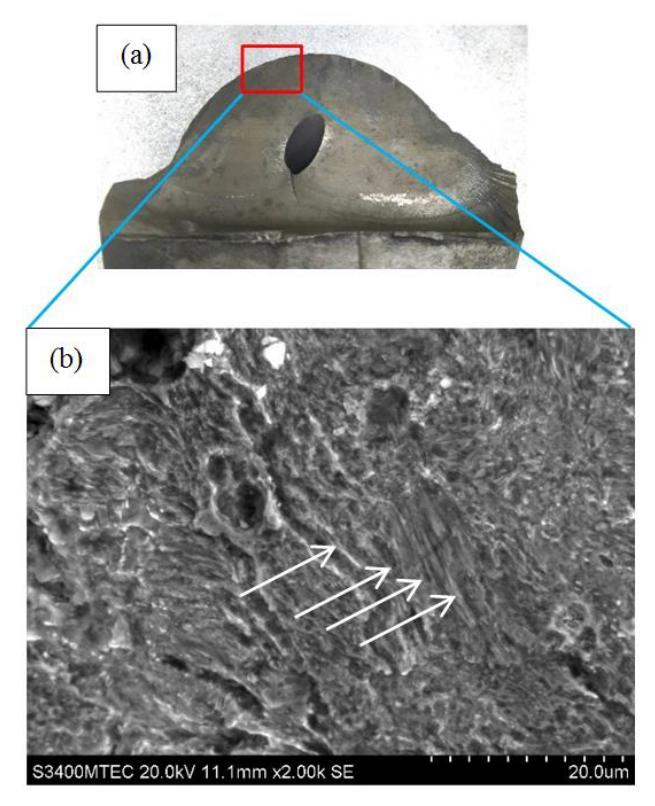
Fig. 7. SEM micrograph showing (a) SEM micrograph showing 1x. (b) Magnification of the visible fracture area showing fatigue striations and the direction of motion between dislocations of atoms at 2.00kx,  $20 \mu m$ .

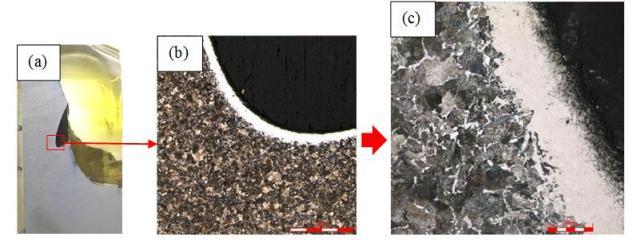
Metallographic examinations as shown in Fig. 8(b) presents the same image at magnification  $200 \times 40 \ \mu m$ . In Fig. 8(c) the surface of the crankshaft shows that the microstructure is composed of perlite-ferrite with a hard coating layer or nitriding layer about 500 mm in size.

Fig. 8. Optical photomicrograph of the failed crankshaft. (a) Low magnification image of the failed crankshaft approximation 1x. (b) The same image at magnification 200×40  $\mu$ m. (c) Magnification of the surface is composed of perlite-ferrite with a hard coating layer or nitriding layer about 500 micrometers in size with a magnification of 1000×50  $\mu$ m.

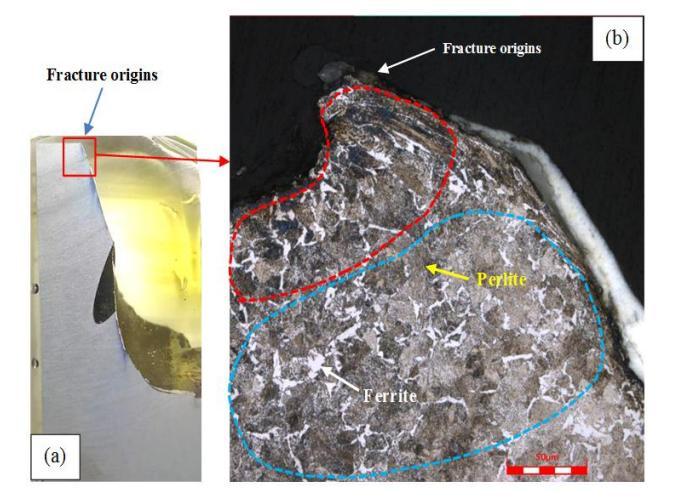
Fig. 9 Optical micrographs of failed crankshaft show (a) Low magnification image (1x) at the outer surface of the shaft. (b) shows the microstructures are perlite-ferrite grain boundary on the fracture initiation region at magnification  $500 \times 50 \,\mu$ m.

The fracture initiation region at the outer surface of the failed crankshaft is shown in Fig. 9(a), the fracture origins in an example. Fig. 9(b) is the same image at

magnification  $500 \times 50 \ \mu m$  at the fracture origin in the red line color, found that the ferrite (white) has a fine grain boundary, and in the blue line color on the fracture expansion zone, it was found that the ferrites had coarse grain boundary than those at the fracture initiation region. Therefore, the size of the grain boundaries of ferrite resulting in decrease mechanical properties and the strength of the material, also have the effect on the fatigue strength of these specific areas [11]. Fig. 10(a) shows low magnification image (1x) with two telescopes at the surface and core of the shaft. Fig. 10(b) The crosssection and microstructure of the outer surface showed some coating layers, most hard coating is not found. Fig. 10(c) The central axis of the crankshaft contains a perlite-ferrite microstructure and manganese sulfite inserted in the ground metal.

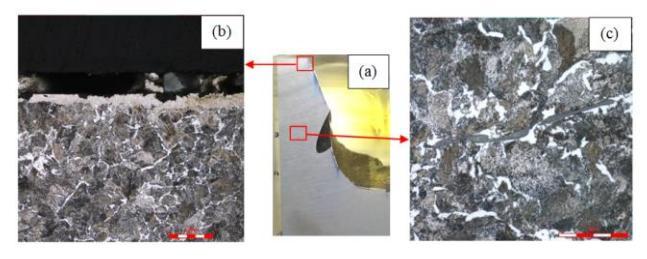
Fig. 10. Optical photomicrograph of the failed crankshaft. (a) Low magnification image of failed crankshaft approximation 1x. (b) Magnification of the outer surface composed of perlite-ferrite showed some coating layers, most hard coating is not found, magnification  $500 \times 50 \ \mu$ m. (c) Magnification of the central axis is composed of perlite-ferrite and found manganese sulfite inserted in the ground metal, magnification of  $1000 \times 40 \ \mu$ m.

- 2. Chemical analysis reveals that the crankshaft is made of JIS-S55C steel. The microstructure is composed of perlite-ferrite on the outer surface showed some coating layers, most hard coating is not found.

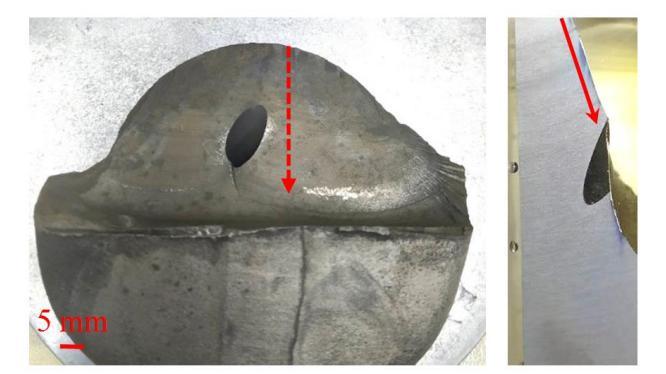
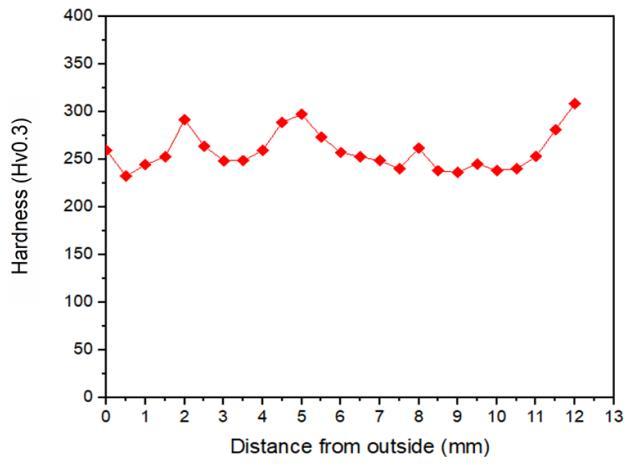
In addition, the microhardness measurement of the cross-section is initiated by pressing from the outer surface of the crankshaft through the center axis in all 25 points of the crankshaft as shown in Fig. 11. The results of the hardness test are shown in Fig. 12, the maximum hardness on the center of the shaft measuring 309 HV, which is more than compared to the outer surface is 259 HV for these applications. It was found that the hardness value was abnormal. This is consistent with the experimental results of the surface microstructure which showed some coating layers, while the hard coating is not found.

Fig. 12. The graph shows the hardness layer of the failed crankshaft.

- 3. The hardness test revealed an uneven hardness distribution, the maximum hardness on the center of the shaft measuring 309 HV, which is more than compared to the outer surface is 259 HV for these applications. It was found that the hardness value was abnormal. This is consistent with the experimental results of the surface microstructure which showed some coating layers, while the hard coating is not found.

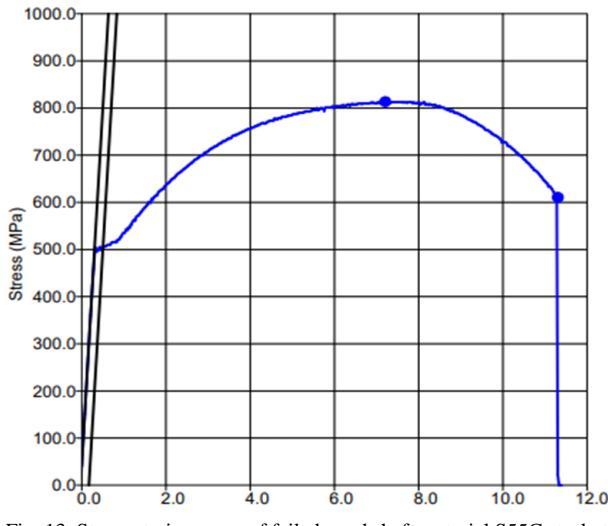
Fig. 13. Stress-strain curves of failed crankshaft material S55C steel at ambient temperature.

Mechanical properties of great importance are tensile tests, which this test will be ultimate tensile strength ( $S_{ut}$ ), elongation and yield strength ( $S_y$ ) and both properties of yield strength and ultimate tensile strength are criteria for resistance to deformation of a material and fracture, respectively. A tensile test was performed on two specimens obtained from the failed crankshaft of a pickup truck. The tensile properties of crankshaft materials compared to the S55C steel properties of standard materials are shown in Table II, and in Fig. 13 a stressstrain curve is illustrated. Observing the data from Table II showing the ultimate tensile strength and overall elongation of crankshaft materials within the tolerance range of standard materials. However, the yield strength is about 9% lower than the high limit of standard material S55C steel [14].

- 4. The tensile test results of the 2 specimens obtained from the failed crankshaft material showed that the elongation and tensile strength values were within the standard values. However, the yield strength was below the high limit value of JIS-S55C standard steel material by about 9%.

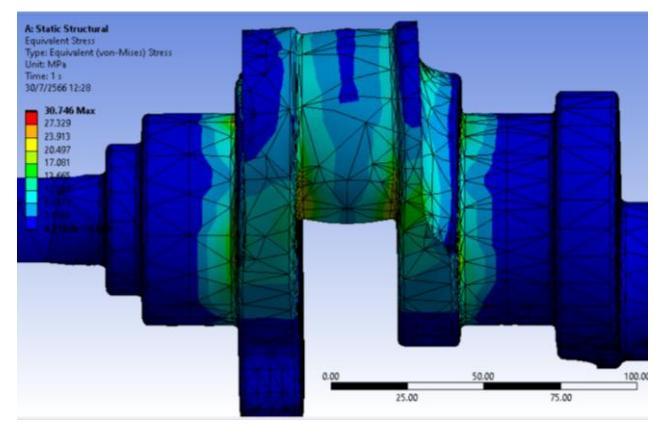
Fig. 17. The von Mises stress distribution in the web fillet of crankpin and fracture region.

- 5. Numerical simulation results showed the maximum equivalent von Mises stress at the crankpin-web zone of the crankshaft is 30.746 MPa, which is 6% of the yield strength of the crankshaft standard material S55C steel.

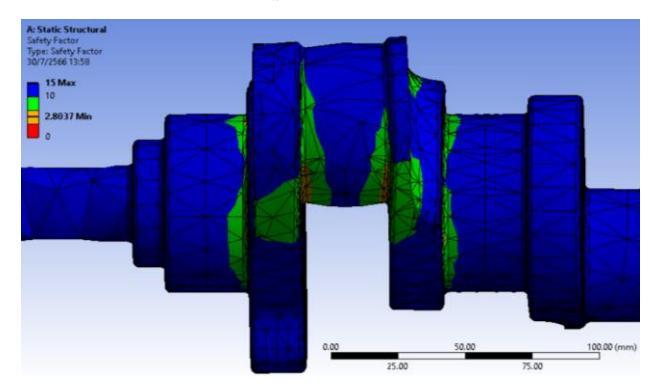
$$n_f = \frac{S_e}{\sigma_{\text{max}}} = \frac{77.70}{30.746} = 2.52$$

Fig. 18. The safety factor obtained from the numerical simulation.

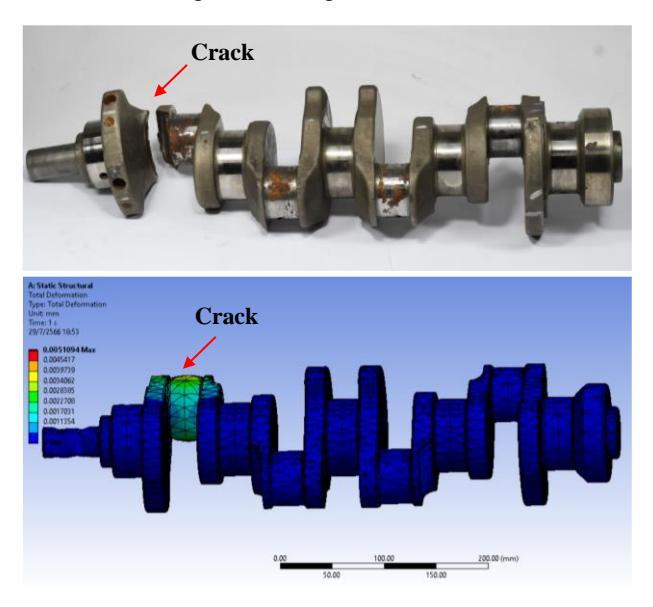
Based on the results of numerical simulation using the ANSYS Workbench program as shown in Fig. 19, the maximum equivalent von Mises stresses in the crankshaft can be observed to deliver a maximum deformation at the junction between the first crankpin and the web, similar to the appearance of crankshaft cracks caused by fatigue after use for 125,000 km. In conclusion, the cause of the crankshaft damage is the fatigue of the shaft material.

Fig. 19. Comparison of crack appearance between actual usage and stress obtained by simulation using ANSYS Workbench program.

- 6. The results from the numerical simulation present the total deformation at the web crankpin fillet zone, which is similar to the appearance of crankshaft cracks caused by fatigue after the usage for 125,000 km. In conclusion, the cause of the crankshaft damage is the fatigue of the shaft material.
