Fracture Analysis of S45C Medium Carbon Steel for the Van Front Drive Shaft

Abstract—In this study, the drive shaft failure mode in a van is investigated by evaluation of the macroscopic and microscopic morphologies of the fracture surface, chemical composition, metallographic analysis, mechanical characteristics of the material, drive shaft fatigue test and finite element analysis. JIS-S45C hardened medium-alloyed steel was used to make the drive shaft. The failure mechanism for this drive shaft was mixed, which means that it was a combination of both brittle and ductile fractures. This is evident in the central interior region of the drive shaft. The summary result of this drive shaft fracture surface was that fatigue was the cause, and fatigue was the dominant mechanism of drive shaft failure due to obvious beach marks at the fracture surface and dimples at the central region. The shaft surface has a maximum hardness of 300 HV, while its centre axis has a minimum hardness of 214 HV. Additionally, the results of the R.R. Moore fatigue life assessment were compared with the outcomes of the numerical simulations performed using the ANSYS program. It was found from the fatigue expe

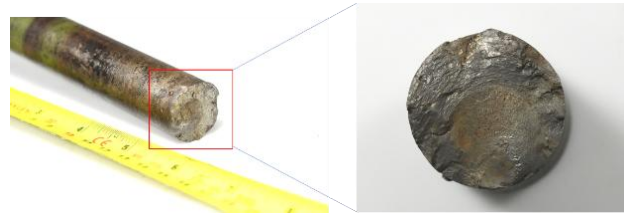
Fig. 1. Cutting position for macroscopic and microscopic examinations.

surface was subsequently investigated more closely via scanning electron microscope (JEOL: JSM-7800F prime). A drive shaft was used as the specimen, shown in Fig. 1.

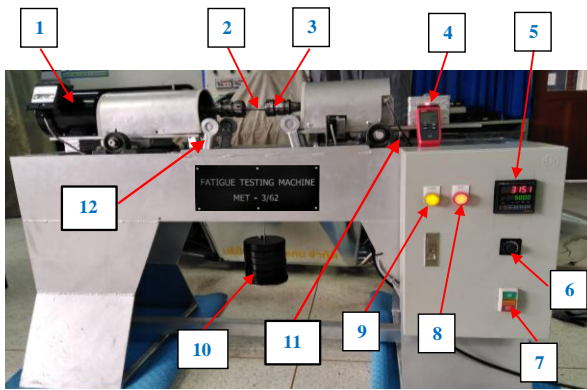
Fig. 3. Fatigue testing machine R.R. Moore.

In fatigue testing, the specimens are turned into 6 pieces with an 8 mm diameter and 90 mm length from failed drive shafts, as shown in Fig. 2. For the testing conditions, it should be noted that all fatigue tests are performed based on ISO standards [9]. The testing machine is composed of many fundamental components to which a number is assigned. Table I describes the numbered components of the R.R. Moore testing machine shown in Fig. 3. The test specimen has to be clamped at both ends, and then the constant test specimen is exposed to a load. The upper and lower surfaces of the specimen will be tensile and compressive, respectively, and the specimen will deflect. Then, the motor is turned until the specimen fractures. A digital revolution counter is required to record the number of revolutions until the failure happens, which is equivalent to the fatigue life of the shaft, whereupon a graph is created to show the relationship between stress and the number of cycles.

TABLE I. CONSTITUTIVE COMPONENTS OF TESTING MACHINE

No.	Description	No.	Description
1	Electric Motor	7	On/Off Switch
2	Specimen	8	Start Light
3	Taper Fittings	9	Stop Light
4	Motor Tachometer	10	Standard Weight
5	Revolution Counter	11	Limit Switch
6	Variable Speed Drive	12	Holding Arm

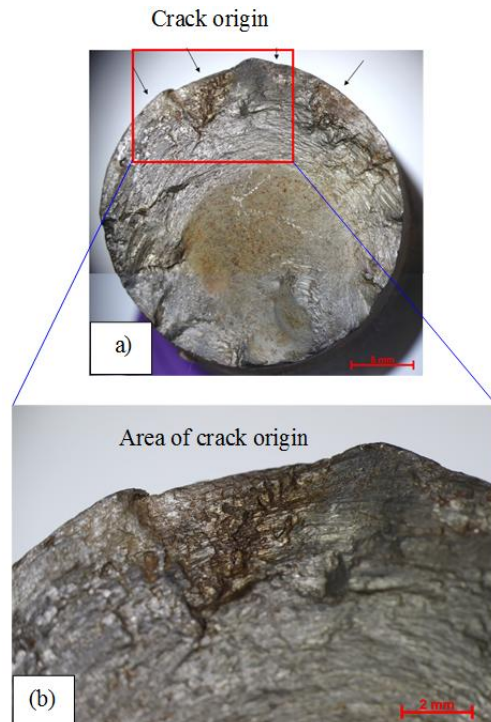
Multiple crack sources were really initiated when low magnification drive shaft fracture surfaces were examined using a zoom stereo microscope, as shown in Fig. 5(a). During this slow crack growth, there were variations in the load that resulted in corresponding variations in the crack growth rate, which appear as beach marks confirming that the failure mode is a brittle fracture. The crack continues to grow slowly across the fatigue zone or areas that have been damaged by cyclic loads. The overload zone occurred when the crack eventually got to the point where the remaining material was under stress. An expanded view of the origin of the crack is shown in Fig. 5(b). Consider the examination in the image and compare it with the fatigue crack in Fig. 6. It was found by examination of the schematic diagram that reversed bending was the problem [10–15].

Fig. 5. The drive shaft's fracture characteristics as a result of fatigue.

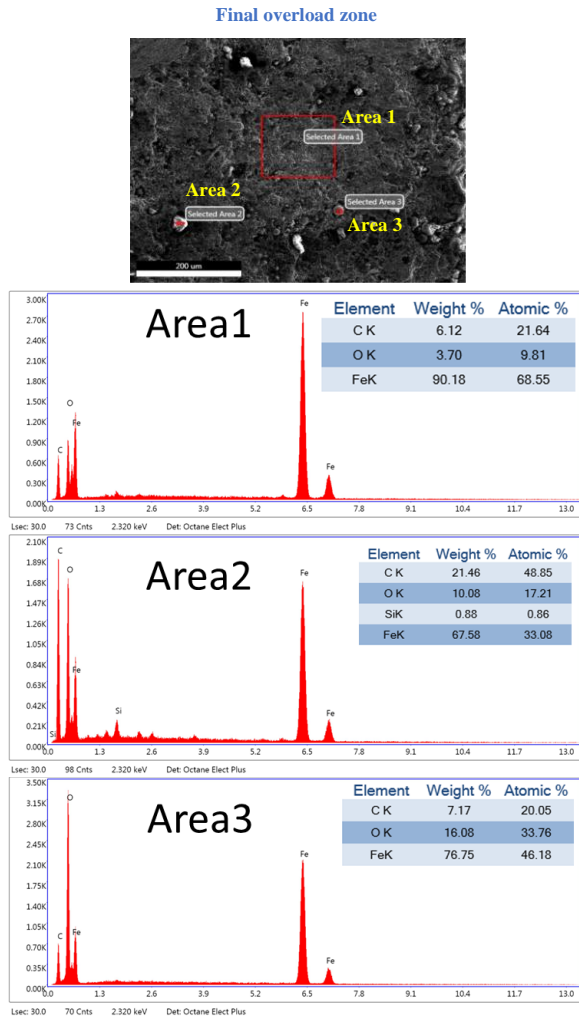
Fig. 9 shows an inspection of the surface layer on the final overload zone in Areas 1, 2, and 3. SEM was used to analyze the chemical composition of the fracture surfaces using energy dispersive Spectroscopy (EDS) for inclusions at the drive shaft fracture surface in Areas 1, 2, and 3. The line of scan shows that most of the elements within the standard percentage by weight of the steel

material are iron (Fe), Carbon (C), Silicon (Si), and Oxygen (O). The drive shaft composition was confirmed to be medium alloy S45C with no abnormalities [17].

Fig. 9. The EDS results on the final overload zone from Areas 1, 2 and 3.

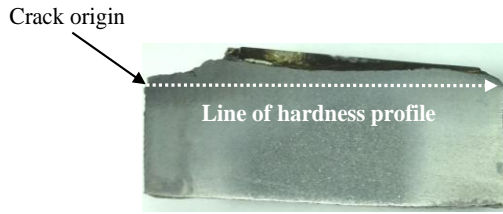
Additionally, as shown in Fig. 12, microhardness examinations are performed by pressing the cross-sectional initial to the outer surface of the shaft through the center axis, oriented in the direction of pressing to the other surface of the drive shaft. Fig. 13 shows the results of the hardness measurements. The surface hardness at the initial position was 275 HV (26.5 HRC), then it decreased radially to reach the lowest value in the shaft at the centre, which was 214 HV (16 HRC), before reaching the hardness value of 300 HV (30 HRC). It was proposed that the axle underwent induction hardening based on the observed microstructures and this hardness profile [20].

Fig. 12. The failed drive shaft hardness measurement line is measured from the case to the core of the shaft.

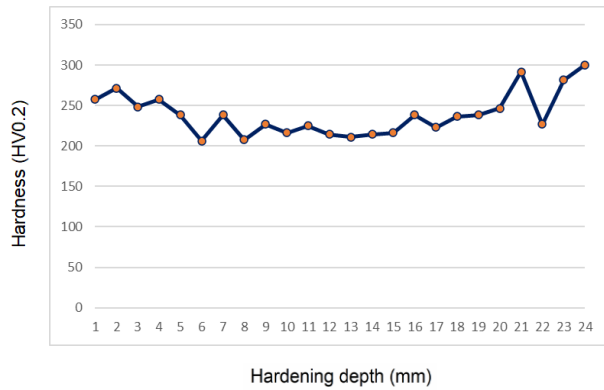
Fig. 13. The graph shows the hardness layer of the failed drive shaft.

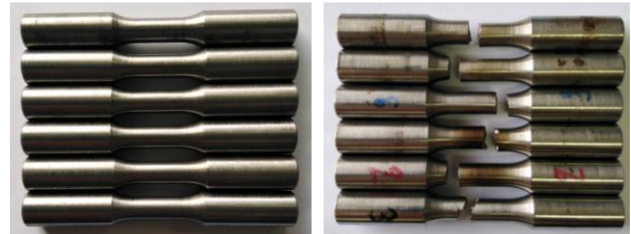
Fig. 14. S45C steel was used for fatigue testing before and after the experiment.

The tensile strength and yield strength of the medium carbon steel S45C shaft material is 569 MPa and 343 MPa, respectively [21]. The loading frequency was 50 Hz, which was a motor speed of 1725 rpm. All fatigue tests were carried out at an ambient temperature of 25 °C. The applied loads for stress levels were considered as 150, 145, 140, 135, 130, and 125 N, respectively. The specimen for the fatigue test is shown in Fig. 14 and was made of medium carbon steel S45C that was obtained from a failed drive shaft. This method was carried out in parallel with numerical simulations of the test specimens using the ANSYS software; stress values for Von Mises stress and endurance limits were obtained from the simulations with a load of 150 N, as shown in Figs. 15 (a)–(b), respectively [22].
