Research Paper

EXPERIMENTAL STUDY OF FRICTION STIR WELDING OF 6061-T6 ALUMINUM PIPE

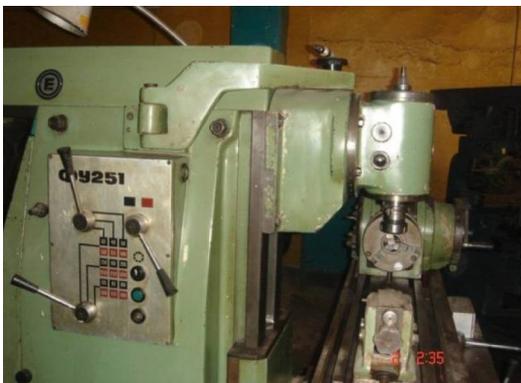
Due to of the non availability of specialist machine in Iraq for FSW process. A conventional vertical milling machine was used to attempt the welding process as shown in the Figure 1. The machine must has the ability to apply significant pressure on z axis direction, wide range of spindle speed, enough space for its working table to holding the welding assembly and rigidly during the welding operation.

Figure 1: Milling Machine

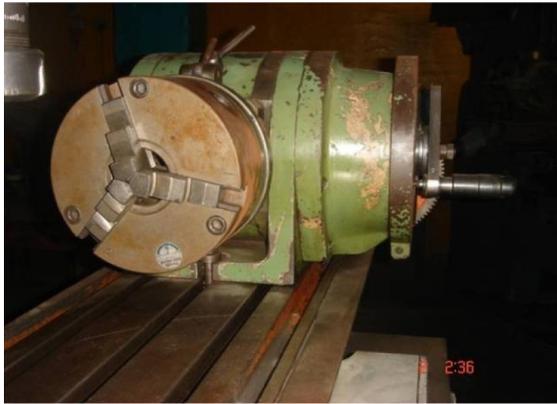
- Gear box with a rotating clamp hold the pipe from one side and can be fixed tightly to the working table of the milling machine as shown in Figure 3, the reduction ratio for the gearbox is 40 to 1 rpm.
- Fixing mandrel hold the other side of pipe and tightly forced to the two pieces, preventing them from any horizontal movement during welding process. The mandrel can freely rotate 360 degree with rotational speed of pipe and also can be fixed on the working table of the milling machine as shown in Figure 4.

Figure 3: Rotating Clamp Gearbox

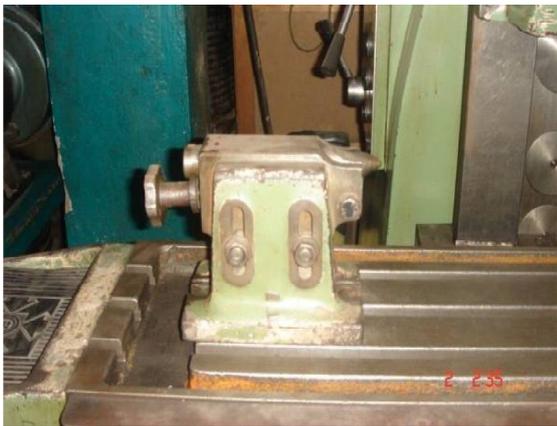
Figure 4: Fixing Mandrel

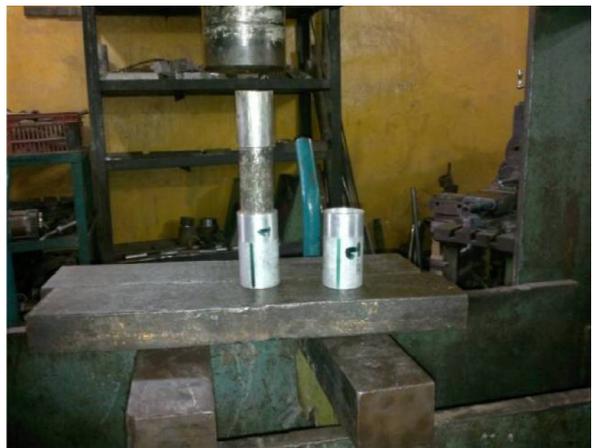
Figure 6: Hydraulic Press

- To provide the internal pipe support to prevent wall collapse due to the high pressures exerted by the FSW process, an internal, anvil was designed. anvil fixed inside the two pieces of pipes before welding operation by use hydraulic press. Figures 5 and 6 show the anvil, fixing hydraulic press
- An external anvil used to prevent bending of the two pieces of pipe due to the force applied from the tool and tool shoulder during welding operation. Figures 7 and 8 show the external anvil position during welding operation.

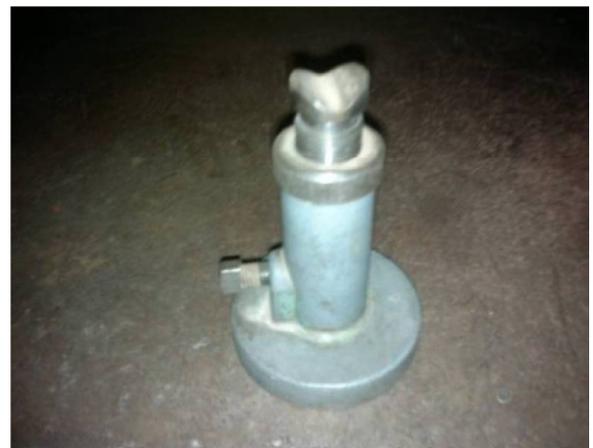
Figure 7: External Anvil

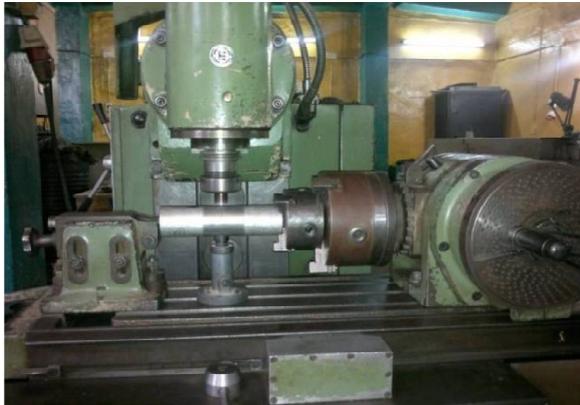
Figure 8: External Anvil Position

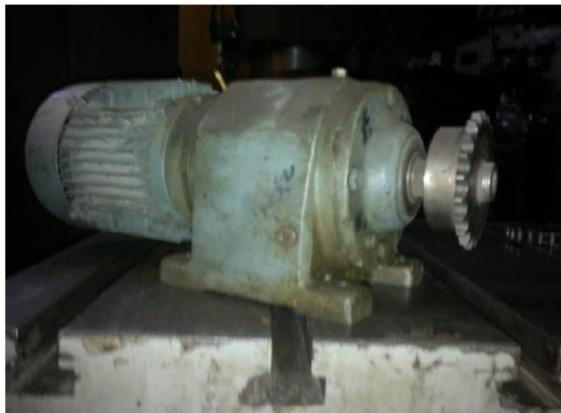
- To have the rotational speed for the clamping gearbox, driving gearbox connected to it by means of two gears and chain as shown in the Figure 9.

Figure 9: Driving Gearbox

Specification of driving gearbox. Reduction ratio 1500 to 80 rpm.

Motor 380V, 50HZ, 0.75hp.

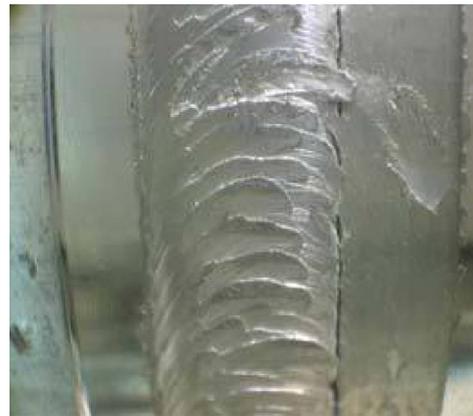
- Initial starting point is the most important that pin must be come to the interface both pipes. Besides, the bond desired between the both pipes cannot be taken place well. And also, some gaps and cracks can be occurred as shown in Figure 11.

Figure 11: The Welding Surface Near the Initial Point

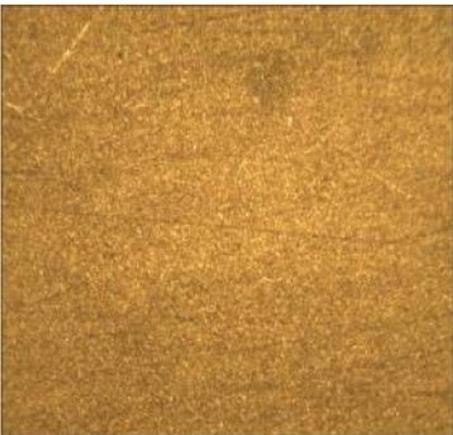
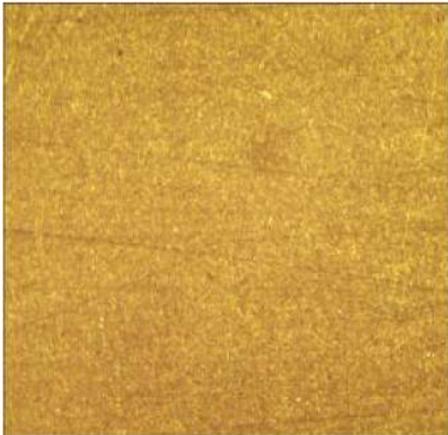
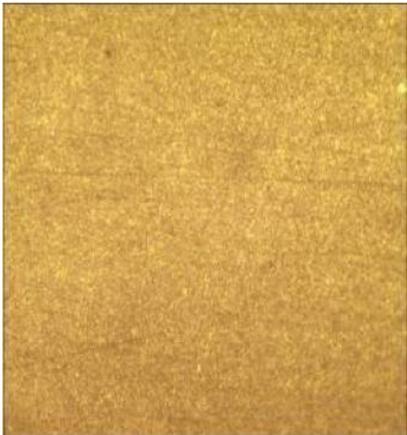
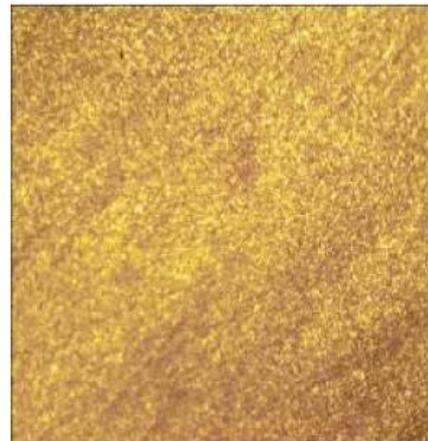
Figures 18-28 shows the microstructure of nugget zone (WN) for all parameters used in this study, it shows the degree of refining grain size for every type of welded joints.
