# Failure Analysis of Hydraulic Rotary Drill Rods in a Limestone Mine

Abstract—Failure analysis of two hydraulic rotary drills used for rock drilling was carried out. Chemical analysis, metallurgical examination, surface fractography and hardness measurement were used for the analysis. The failed drill rods composition matched with low alloy 31NiCrMo13-4 grade steel. The hardness measurement results suggested that the drilled rods were surface hardened. Surface fractography examination revealed that crack initiation of the fractured drill rods started at the outer surface, especially at the joint between the drill rod and drill bit. The mode of failure was found to be fatigue. The stress concentration locating at groove of threads at the joint was likely to cause the crack initiation. Propagation of fracture was observed with the evidence of beach mark, resulting from continuous nominal low stress.

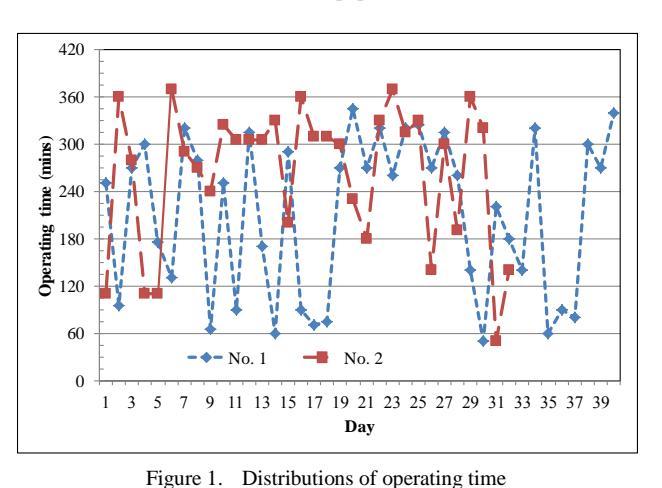
Further data analysis, the operating times of the drill rods in each day were plotted against the consecutive operating day. The distributions of operating time of the drill rods were shown in Fig. 1. It can be suggested that the second drill rods (No. 2) were used in more intensive operations, comparing to the first drill rod (No. 1). The average operating time of the second was higher than that that of the first, resulting in a shorter period of use (32 days). Moreover the rates of drilling for each drill rod were analyzed over the operating time as shown in Fig. 2. It can be seen that the second drill rod (No. 2) was operated with relatively high drilling rate (>40m/hr) within 7 days before failure.
