# Failure Analysis of S55C Medium Carbon Steel for the Pickup Crankshaft

**Abstract**—There have been reports from service centers of important problems of a diesel engine crankshaft in mini trucks. All crankshafts crack from the same region, the fracture occurred in the first crankpin of the crankshaft. The crankshaft is made from JIS-S55C hardened medium carbon steel. A series of experiments including chemical analysis, macro and microstructural analysis, mechanical properties test, and numerical stress analysis. The results of fracture surface of this crankshaft were caused by fatigue with the detection of beach marks, ratchet marks, river marks, cleavage fracture and fatigue striations which these results indicate that the fracture mode of brittle fracture. The microstructure is composed of perlite-ferrite on the outer surface showed some coating nitriding layers, most hard coating is not found, the hardness test revealed an uneven hardness distribution, the maximum hardness on the center of the shaft measuring 309 HV, which is more than compared to the outer surface is 259 HV for these applications. It was found that the hardness value was abnormal. This is consistent with th

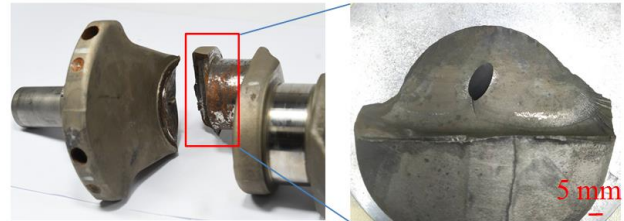
Fig. 1. Cutting position for macroscopic and microscopic examinations at 1x.

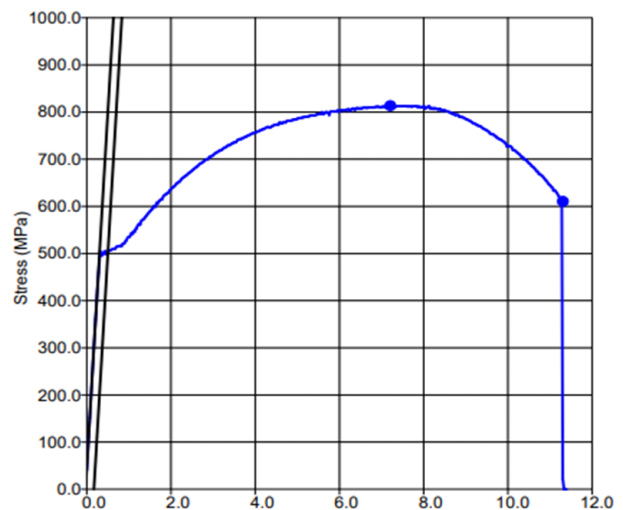
Fig. 13. Stress-strain curves of failed crankshaft material S55C steel at ambient temperature.

Mechanical properties of great importance are tensile tests, which this test will be ultimate tensile strength ( $S_{ut}$ ), elongation and yield strength ( $S_y$ ) and both properties of yield strength and ultimate tensile strength are criteria for resistance to deformation of a material and fracture, respectively. A tensile test was performed on two specimens obtained from the failed crankshaft of a pickup truck. The tensile properties of crankshaft materials compared to the S55C steel properties of standard materials are shown in Table II, and in Fig. 13 a stress-strain curve is illustrated. Observing the data from Table II showing the ultimate tensile strength and overall elongation of crankshaft materials within the tolerance

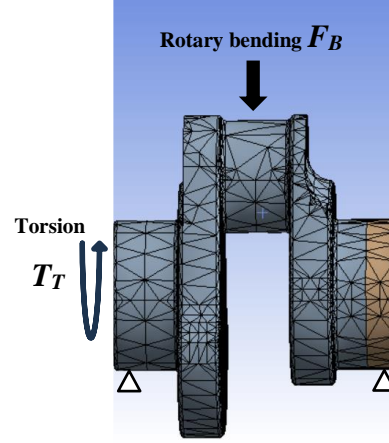
The final step was to determine the mechanical properties of the crankshaft material by entering a modulus of elasticity of 200,000 MPa, a density of 7.7 g/cm<sup>3</sup>, and a Poisson's ratio of 0.3 [13], boundary conditions, loading and mesh type selection applied to this numerical simulation refer to [16]. Table II is used to apply mechanical and loading properties respectively. Axial load distribution towards the bearing of 120 degrees uniform pressure over the contact area. The load distribution was experimentally performed using the method of Webster *et al.* [17], and a numerical simulation method followed the method of Zhang *et al.* [18]. Elements of the Tetrahedral type were selected to the generated mesh operation models have 44,922 total elements, 76,410 total nodes and 43,655 Degrees of Freedom (DOF) for mesh control x, y, and z axes only, which is suitable for complex geometries. According to the engine's maximum pressure of 32 bar, the bore diameter and the maximum torsion values in Table III, the bending moment and torsion according to Fig. 16 are

Fig. 16. Characteristics of the mesh control and the force acting on the crankpin of crankshaft.
