A Study on the Stiffness Change of a Passenger Car's Front Frame Body before and after a Collision Accident

Abstract—As cars become one of the main means of transportation, accidents have accompanied car driving. In the event of an accident, the repair is carried out at a repair shop, and in the case of damage to major parts of the car's body, the value of the car falls after the repair or concerns about its performance and safety arise, promptly causing distrust and anxiety over the repaired car. In this experiment, one high-selling passenger car is selected in the domestic market and a collision test is conducted in the same way as the actual vehicle, utilizing the drawings, materials, and relevant data of the car. The simulation identified the damaged area and condition in the same collision as in the actual crash, with the condition of the vehicle after the crash repair being interpreted and analyzed through a commercial program. The tensile strength test for the welded area confirmed that the material strength of the vehicle was reduced by 20% from the intact condition. The change in the stiffness in the vehicular body before and after the accident is compared to gather data

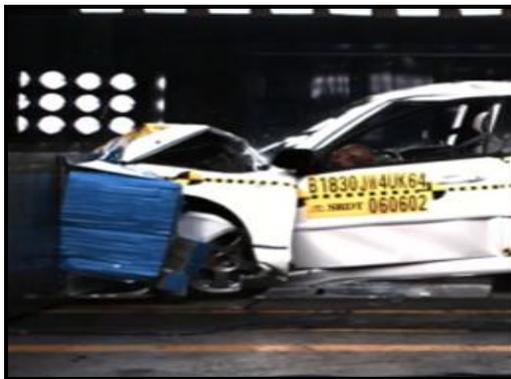
Figure 5. The actual vehicle collision test

Because of the collision characteristics of a car, it is considerably difficult to use the actual driving vehicle to conduct a collision test through a re-occurrence of an accident of a repaired vehicle as show in Fig. 5.
