Analysis of Changes in Roof Crush Resistance of a Vehicle with the Roof and A/B-pillar Repaired after an Accident Following a Subsequent Accident

Abstract—As the automobile has become a major form of everyday transportation, more and more passenger vehicles are on the road each year. Drivers are increasingly at risk of being involved in accidents, and their carelessness behind the wheel often leads to accidents. Most accidents are caused by forward, rear, or side collisions. In the case of a forward collision, the passengers can be protected with the help of the vehicle's frame and engine room to some extent. In case of a rollover accident, the overall stiffness of the vehicle's roof, doors, and pillars ensures that the roof can meet the desired strength requirement, as in a side-collision accident. Roof crush tests are performed to determine whether vehicle's safety cage is sufficiently stiff and rigid to maintain a safe space in the passenger seats in case of an accident. In case of a deformed roof, the vehicle is repaired in a repair shop. Welded joints of the roof replace it with a new one, or they may cut out and repair the damaged pillars & weld back to the roof. These opera

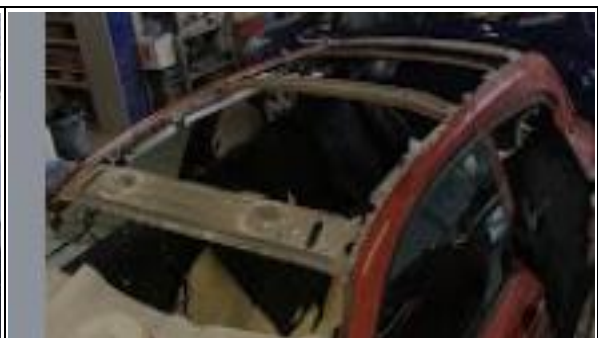
Figure 5. A vehicle with the damaged roof removed.

The structure of the roof (i.e., the A,B,C Pillar & front and rear of door) is required to have sufficient rigidity to keep passengers safe in the event of a rollover accident or falling objects. It is supported by the left and right pillars and protects from external impact. Generally, the pillar part is made of high rigidity material, and three reinforcing plates are installed as separate reinforcements to maintain the strength of the ceiling in the middle of the roof. In addition, small stiffeners were attached to the front and rear parts to maintain the strength of the ceiling. In the analysis, a bracket that maintained the rigidity of the roof was set, and the spot welded part was separately marked for modeling. The modeling of roof when the structure interpretation is applied are shown in Fig. 3. Actual roof damage is shown in Figs. 4 and 5.

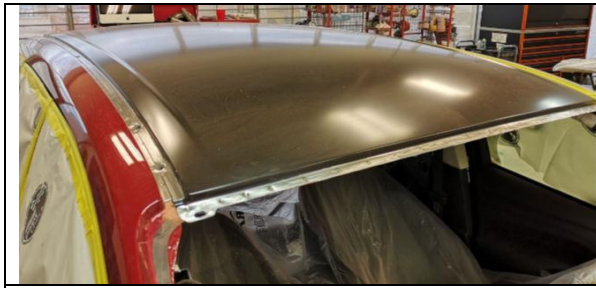
Figure 6. A vehicle with a new roof installed.

- i. Remove the welded joints of the roof using a drill or perforator.
- ii. After drilling out the welded joints, remove the part.
- iii. Locate the damaged portion of the pillars and correct it, if applicable.
- iv. If not, cut it out and prepare a new part of the same size. Weld it in the same place.
- v. Make holes in the new part using a drill. Machine the part to ensure that it can be properly placed in the same place as the original one. Assemble the part by CO₂ welding or spot welding shown in Fig. 6.
- vi. Grind and seal the welded joints and perform painting operations shown in Fig. 7.

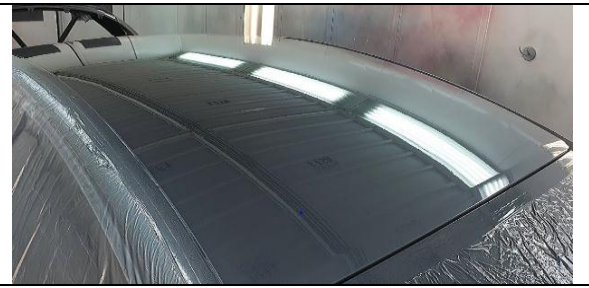
Figure 7. Painting operation following the roof repair.

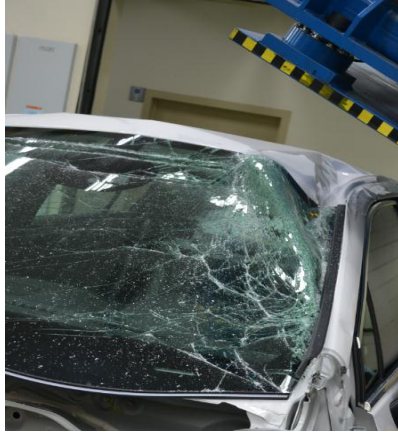
Figure 13. Actual vehicle tests
